**ARCHITECTURE AS A  
GEOGRAPHICAL MATTER:**

*Rethinking Antakya after a  
major disaster*

Énoncé théorique

École Polytechnique Fédérale de Lausanne

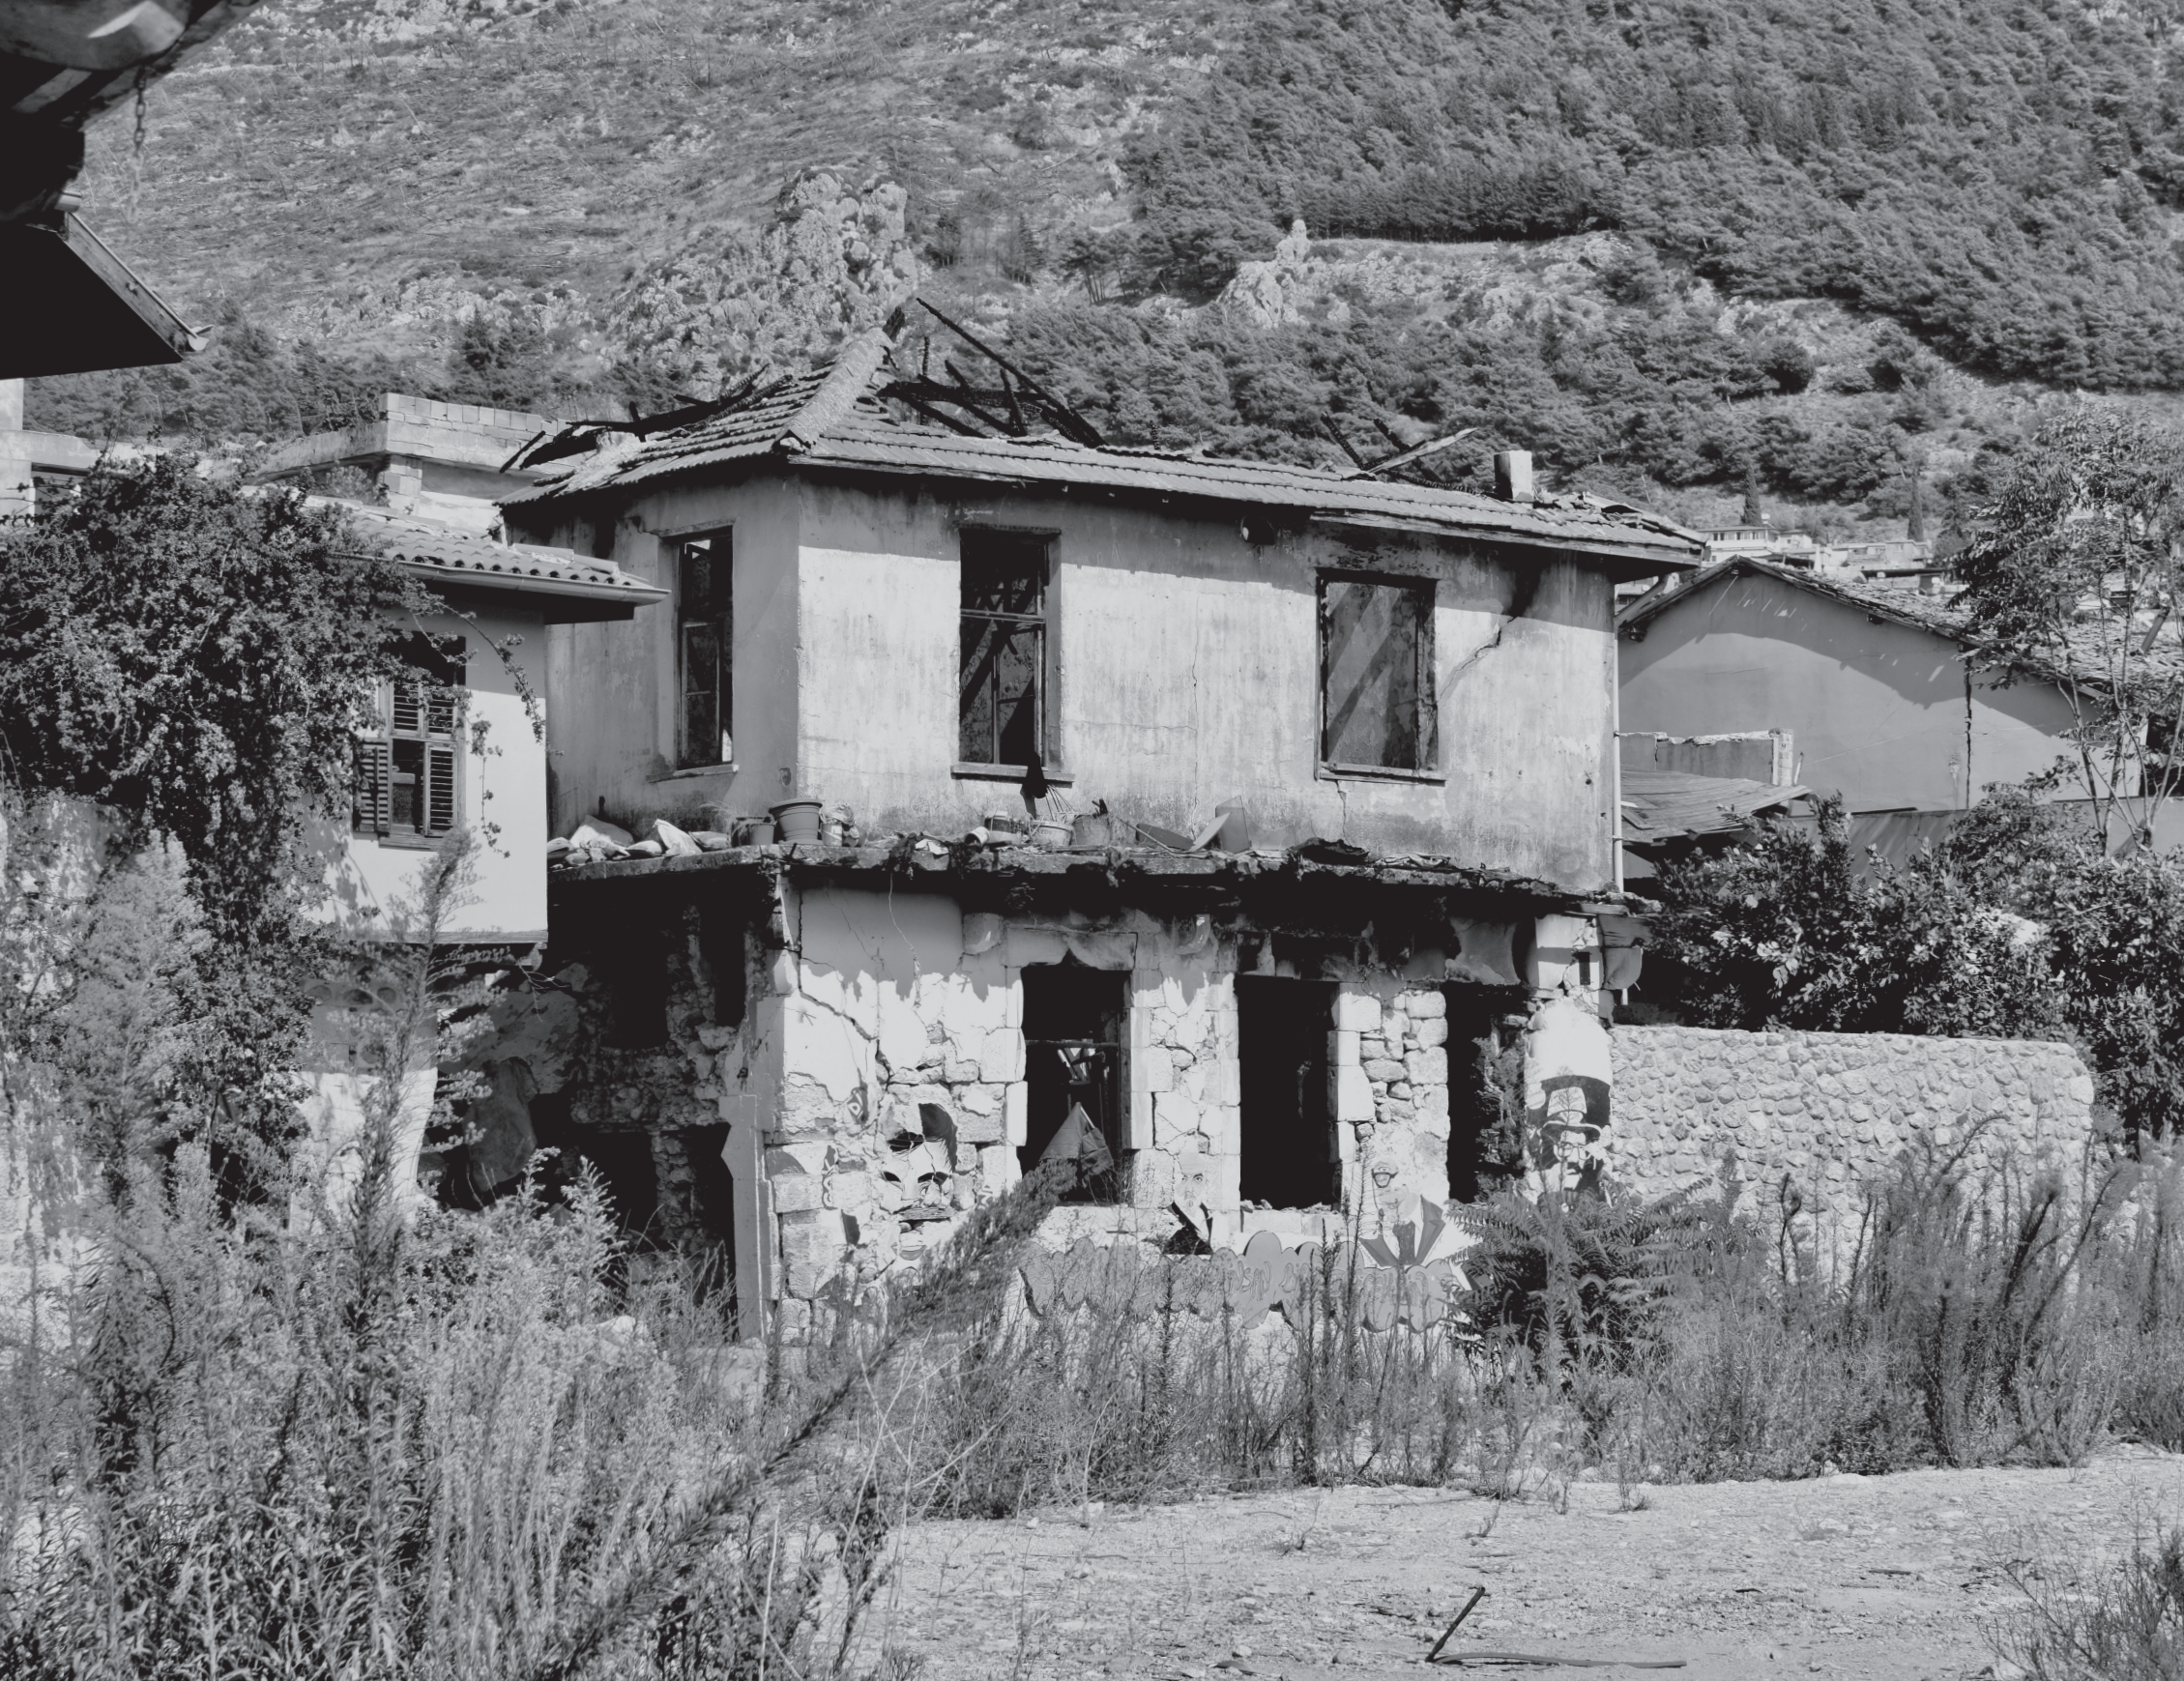
Fig. 14: Traditional houses that endured the earthquake, August, 2024.

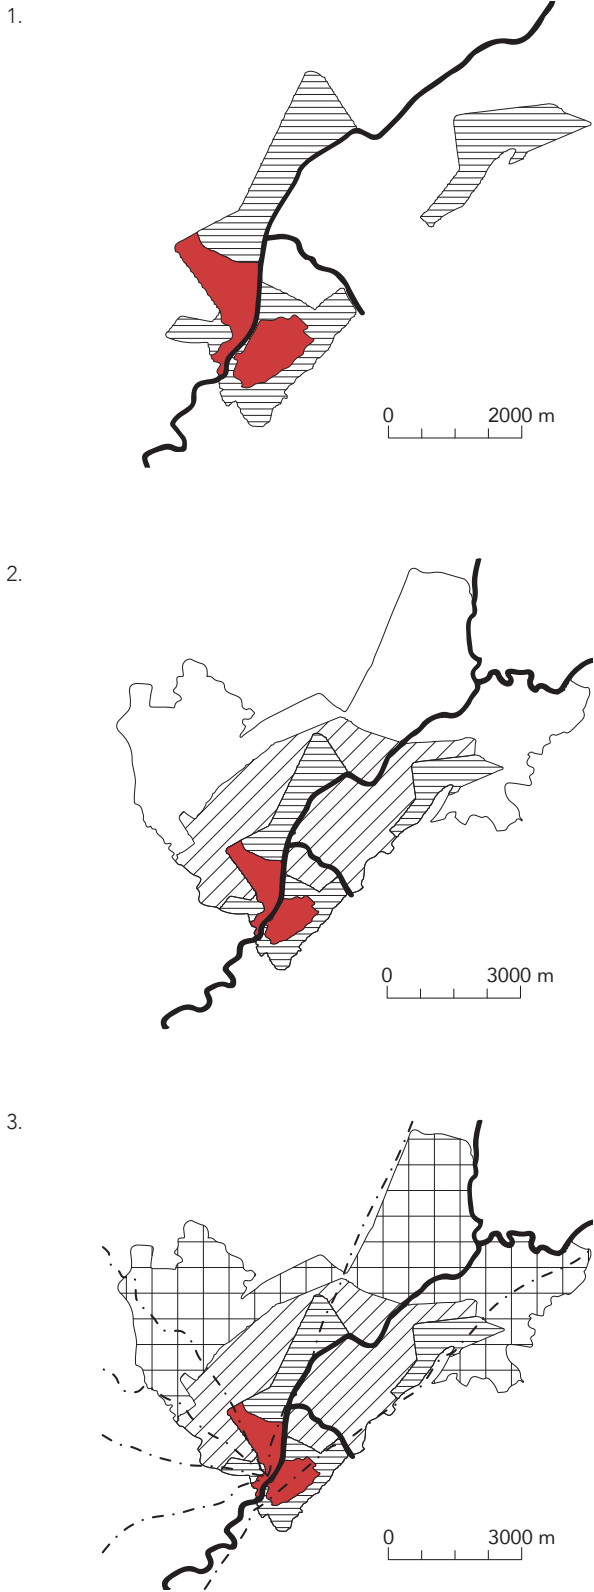
Fig. 15: Historical development map of Antakya

From an economic perspective, the construction sector in Türkiye has played a very important role in the economic development of the country, especially since the 1980s (Fig. 15). In the 80s, Türkiye shifted from an import-substitution industrialization model to an export-led growth strategy, with the construction industry becoming a key driver.<sup>41</sup> The sector further flourished in the early 2000s when political stability and the economic policies of the AK Party government prioritized massive infrastructure projects. This period also saw the private sector grow with large-scale housing and commercial building projects.

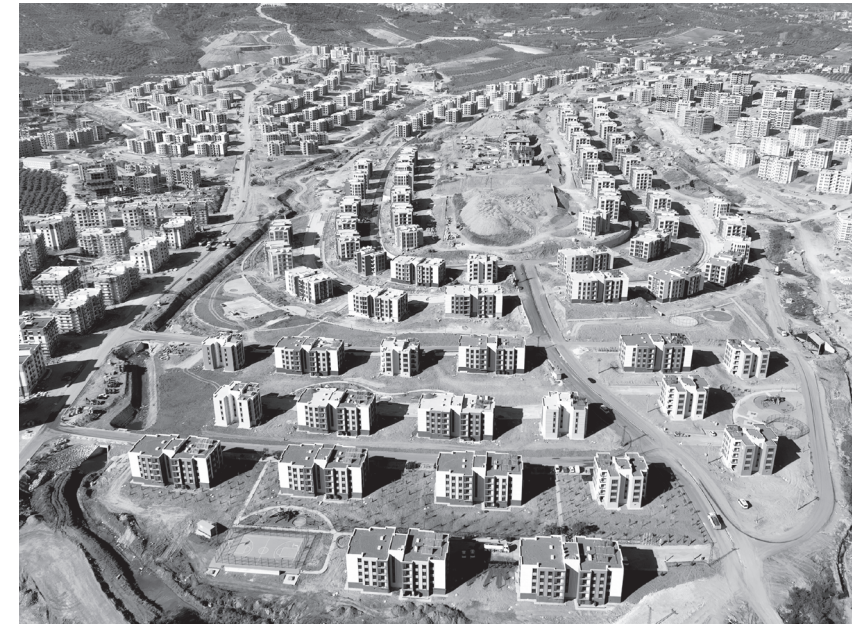
Fig. 22: Republic of Türkiye Ministry of Environment, Urbanization, and Climate Change. "Deprem Bölgesi'nin İkinci Büyük Şantiyesi: TOKİ Hatay Dikmece.", 2023.

On the other hand, since the primary goal of the projects (Fig. 22) was rapid completion, structures that lacked aesthetic consideration and failed to align with the fabric of

the city began to be constructed. The choice for locations of these rapidly spreading projects also created separate issues. These quickly constructed projects that got positioned according to the new urban plan—which is a near-identical copy of the old plans—were placed near active fault lines in many areas of the city. Moreover, especially after the earthquake, despite the abundance of suitable empty space, attention was directed towards century-old olive groves, with trees being cut down to make way for new developments.<sup>66</sup>

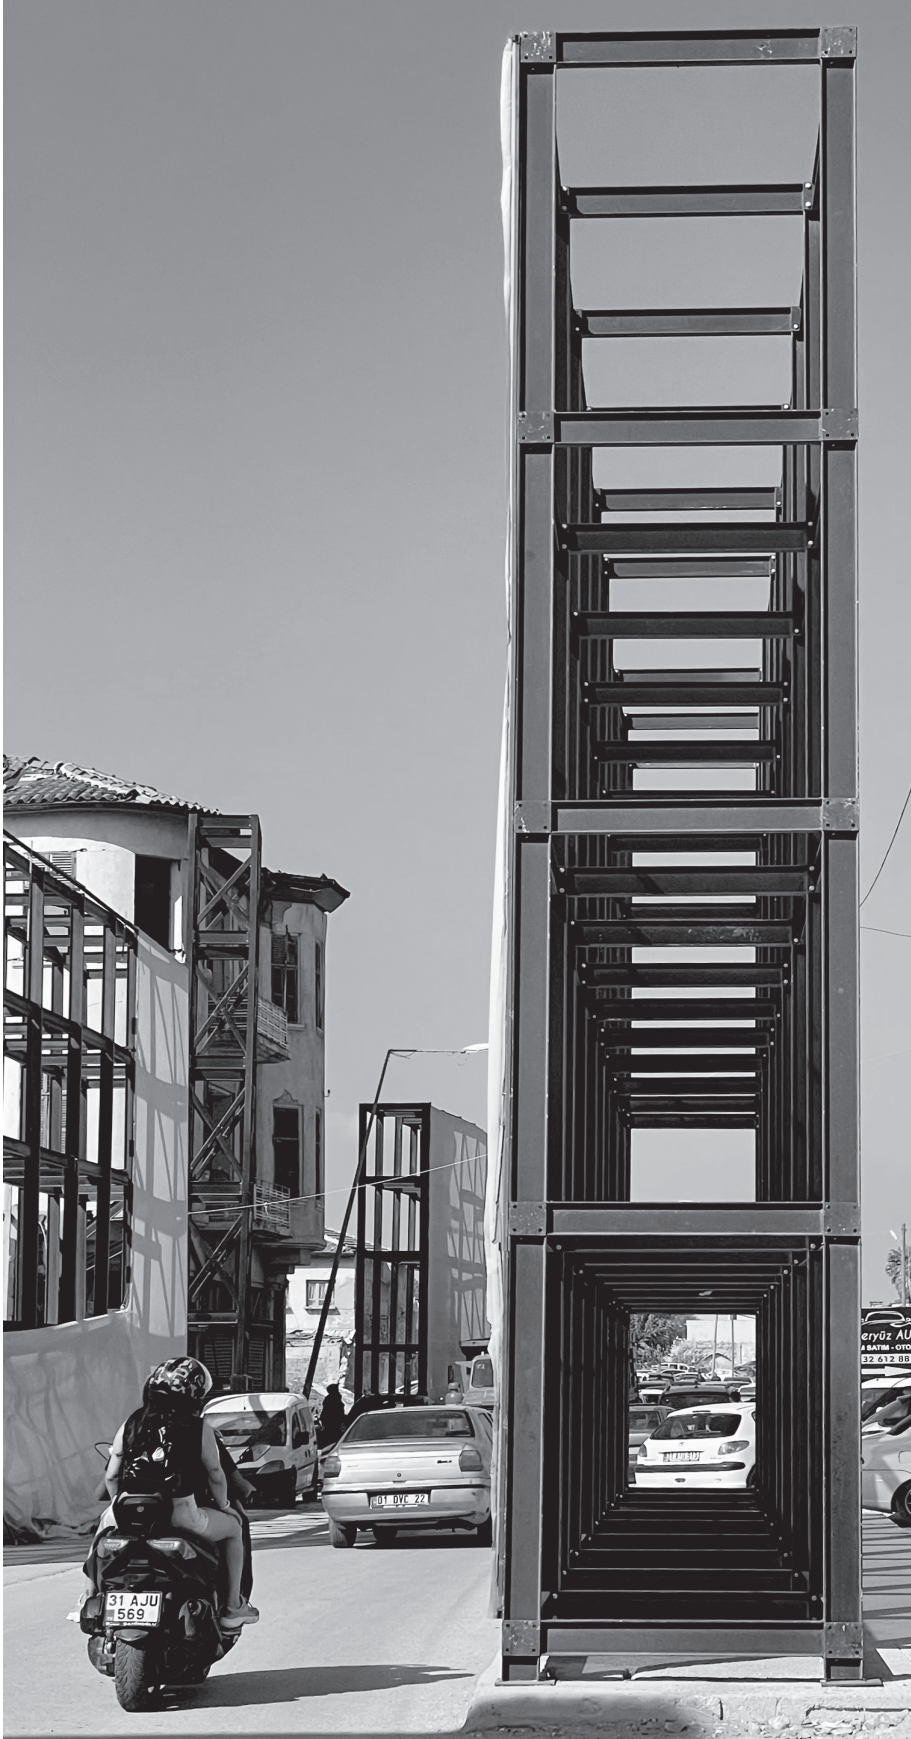
Fig. 23: An empty scaffolding left on Kurtuluş Caddesi, August 29, 2024.

molition, although the debris was cleared, no decision was made to remove the iron scaffolding, leaving empty scaffolds scattered throughout the streets (Fig. 23).

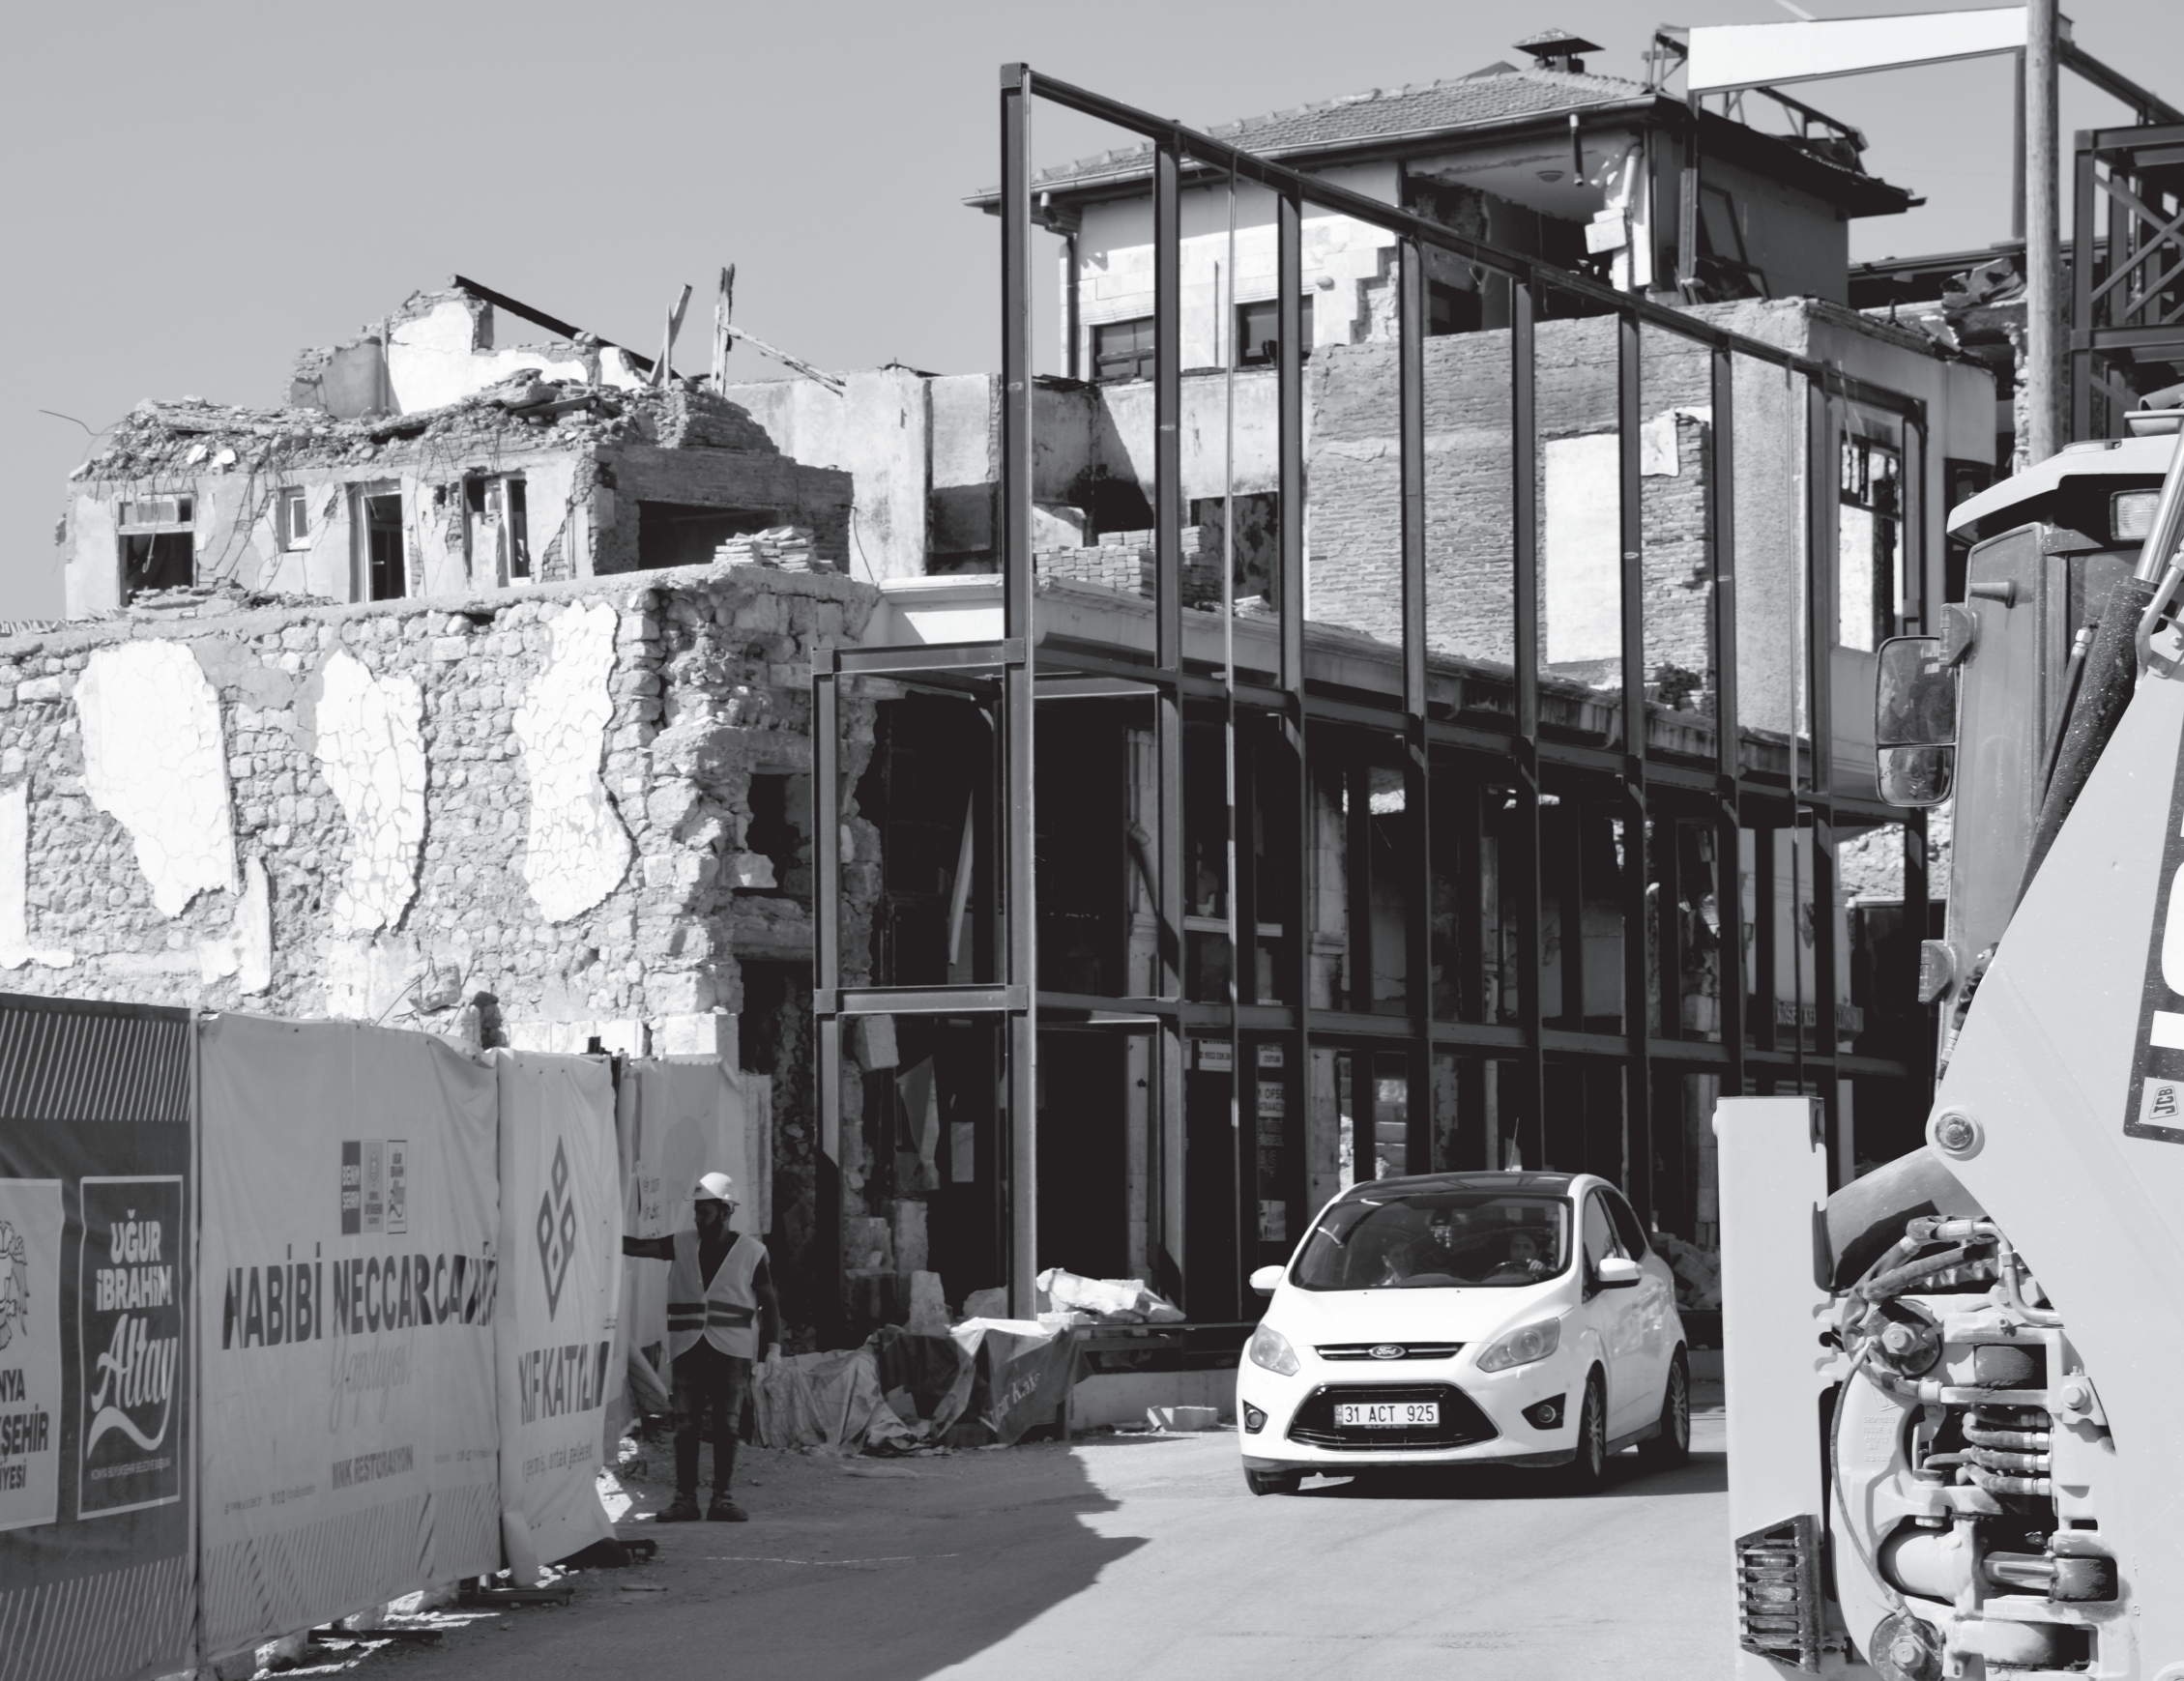
Fig. 24: Efforts to preserve the historic building supported by scaffolding, August, 2024.

For some historical structures under the General Directorate of Foundations, scaffolding was erected in situ before demolition to attempt preservation. However, during a visit conducted on August 29, 2024, it was observed that, despite these efforts, many restoration attempts failed, leading to decisions to demolish these buildings. After de-

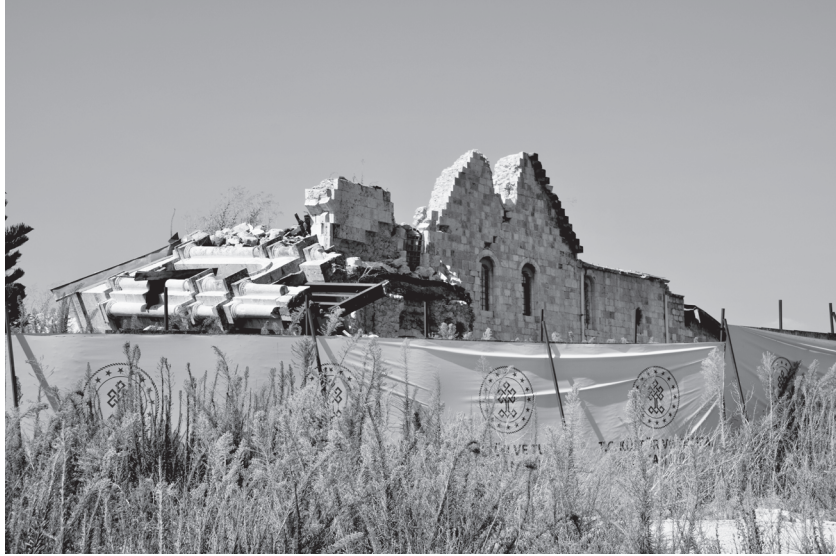
Fig. 26: *St. Paul's Church* after the earthquake, August 29, 2024.

Following the earthquake, several structures in the city, considered as historical and cultural heritage sites, were destroyed. These include Habib-i Neccar Mosque (Fig. 27), Ulu Mosque, the Assembly Building, the Saints Peter's and Paul's Church (Fig. 25), the Latin Catholic Church in İskenderun, and the Church of the Virgin Mary in Vakıflı. The Antakya Synagogue, Sarimiye Mosque, and many other buildings were severely damaged. Almost all of the old Antakya houses on the historical Kurtuluş Street were buried under the rubble.<sup>85</sup>

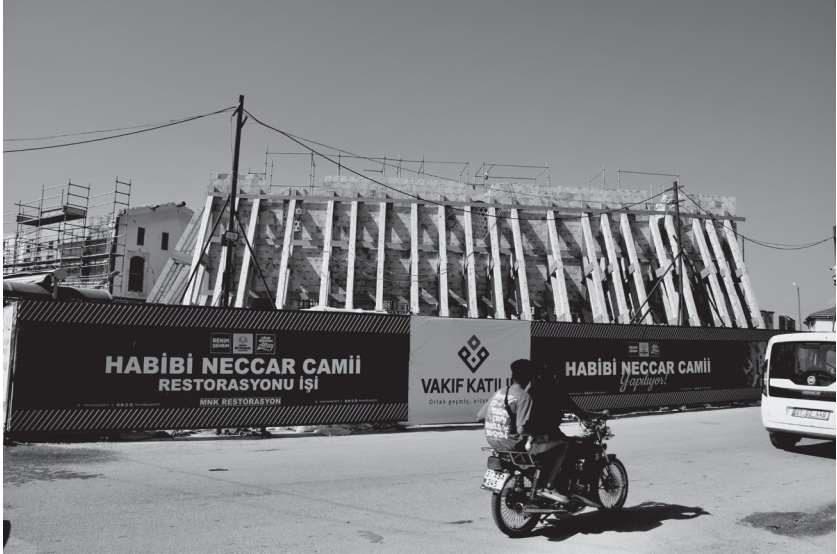
Fig. 28: *Habib-i Neccar Mosque* after the earthquake, August 29, 2024.
